WAYNESBURG WATER COMPANY DAM

NDI I.D. NO: PA-195

PHASE I INSPECTION REPORT  
NATIONAL DAM INSPECTION PROGRAM

D'APPOLONIA CONSULTING ENGINEERS  
10 DUFF ROAD  
PITTSBURGH, PA. 15235  
JANUARY 1979

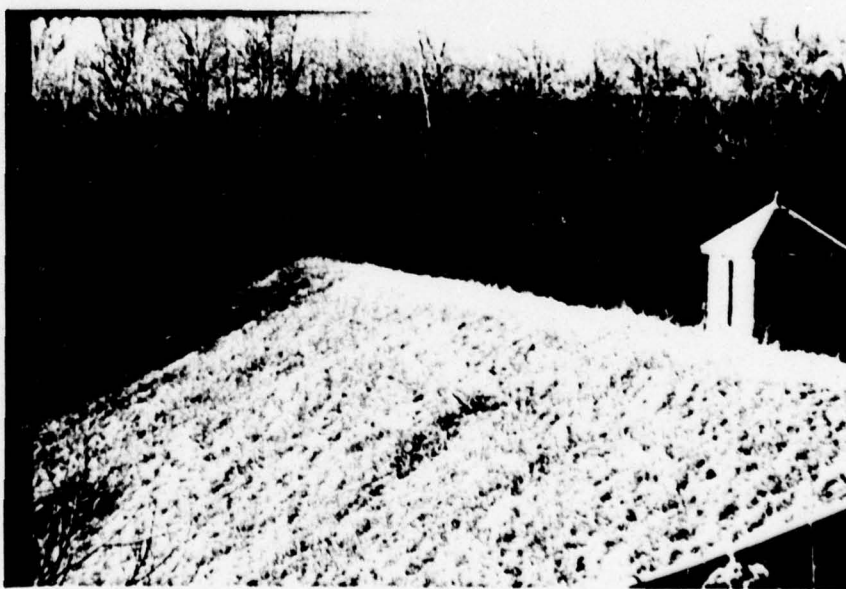
Downstream Face

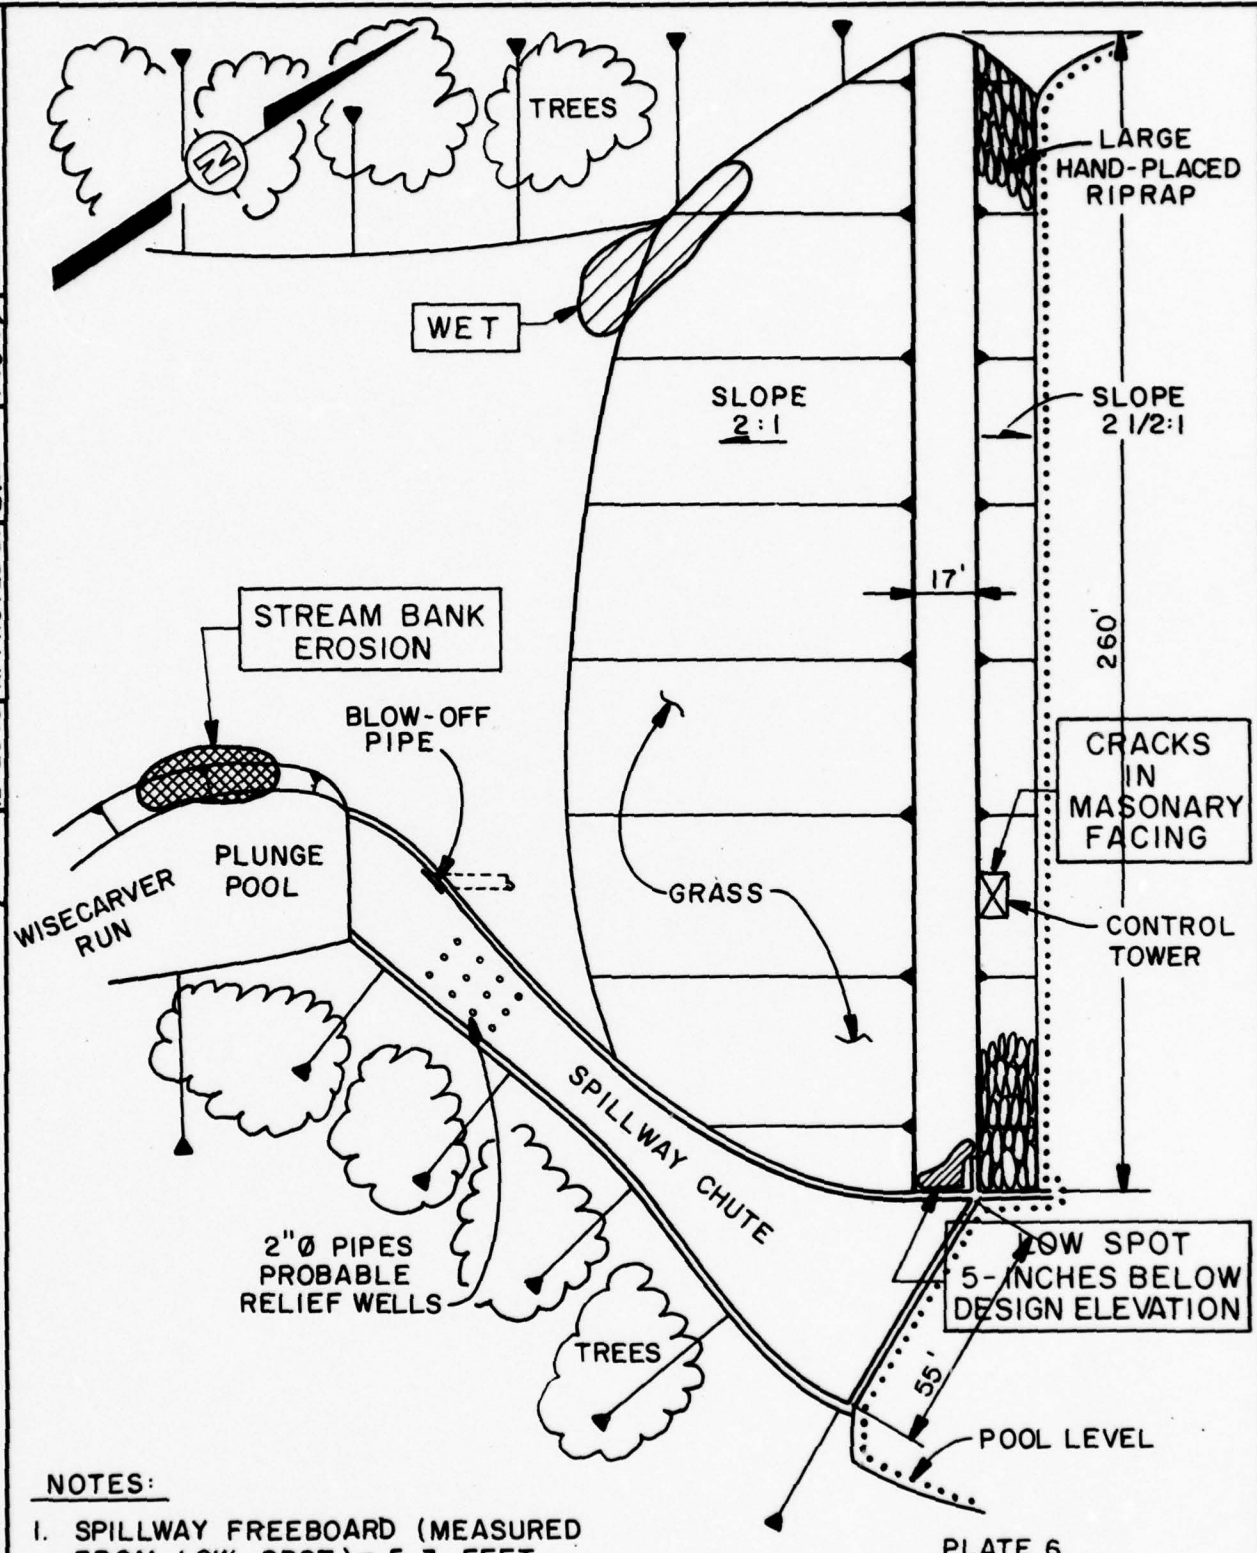
WAYNESBURG WATER COMPANY DAM  
GENERAL PLAN  
FIELD INSPECTION NOTES  
FIELD INSPECTION DATE: DEC. 8, 1978

1. SPILLWAY FREEBOARD (MEASURED FROM LOW SPOT) = 5.3 FEET.
2. POOL LEVEL DATE OF INSPECTION: 1 INCH OVER SPILLWAY CREST.

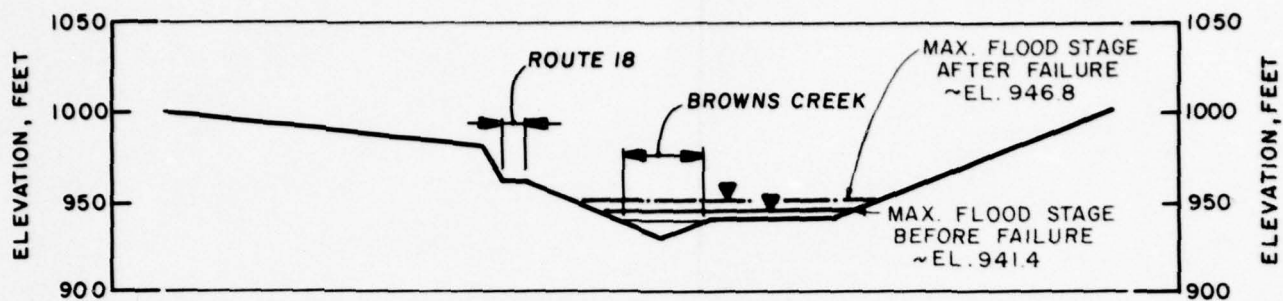
SECTION @ STATION ③

Plate 7 illustrates the cross sections at which the flood stages were determined. The first cross section, which is identified as Station 3, is located across Browns Creek immediately downstream from the mouth of Wisecarver Run. The second cross section was taken across the South Fork of Ten Mile Creek downstream from its confluence with Browns Creek. This cross section was identified as Station 4. Total flow passing through the spillway and over the dam was routed through these sections. In view of the uncertainties involved in the areal distribution of a storm that can cause overtopping failure and for the purpose of isolating and conservatively estimating downstream effects of flow from the dam site alone, discharge from Browns Creek and the South Fork of Ten Mile Creek were neglected in determining the flood stages. The flood stages that would exist just before overtopping failure of the dam are identified in the cross sections in Plate 7. Computer outputs labeled as Step 1 show the flood stages in the potential drainage area (Station 4) prior to overtopping failure.

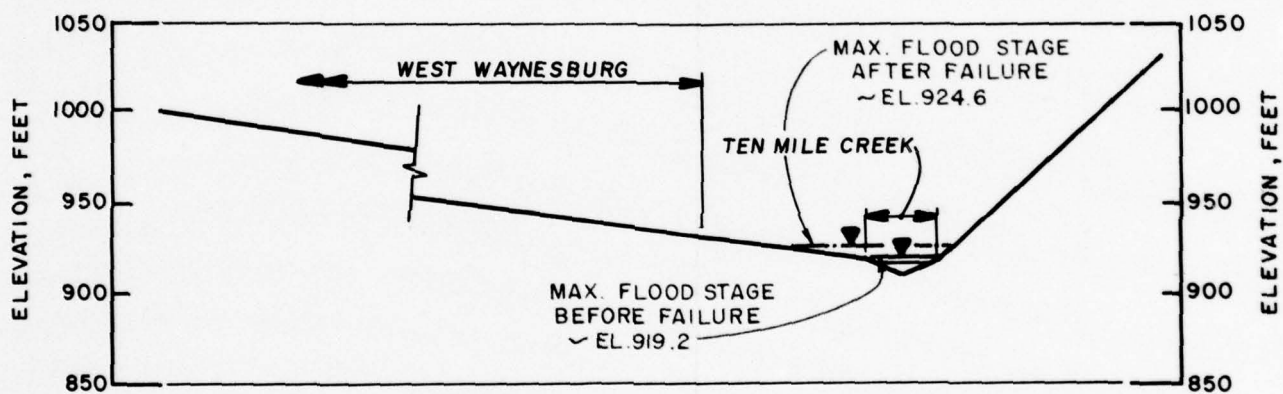
SECTION @ STATION ④

Review of the flood stages in the potential damage area before and after failure indicates that flood stages would be raised by about five feet due to dam failure, and this is considered to be a significant increase in the loss of life or damage potential. Therefore, the spillway is classified to be seriously inadequate.

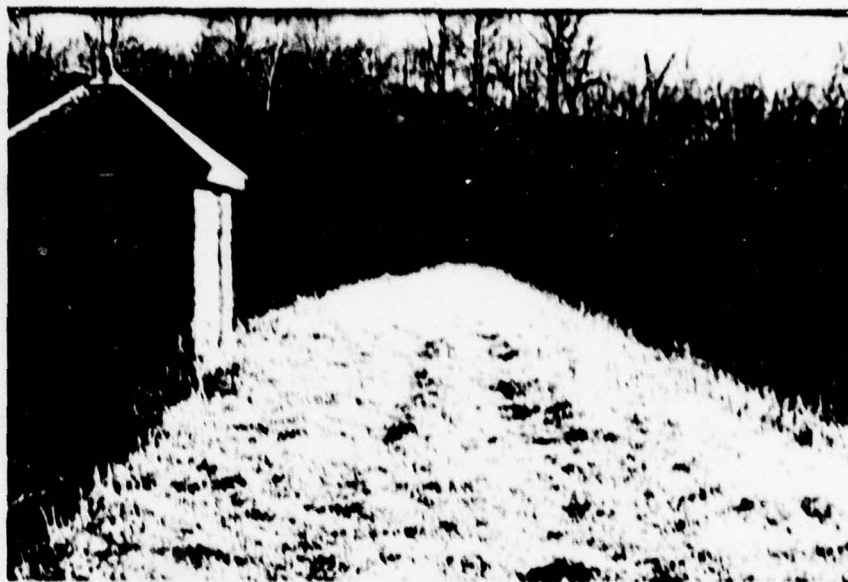
The top of the dam was surveyed relative to the spillway crest elevation and was found to have some vertical irregularities. While the design freeboard for the dam was 6 feet, the survey indicated freeboards ranging from 5.4 to 5.8 feet. The lowest area occurred in a short section adjacent to the spillway.

Photograph No. 1  
Crest (Looking east).

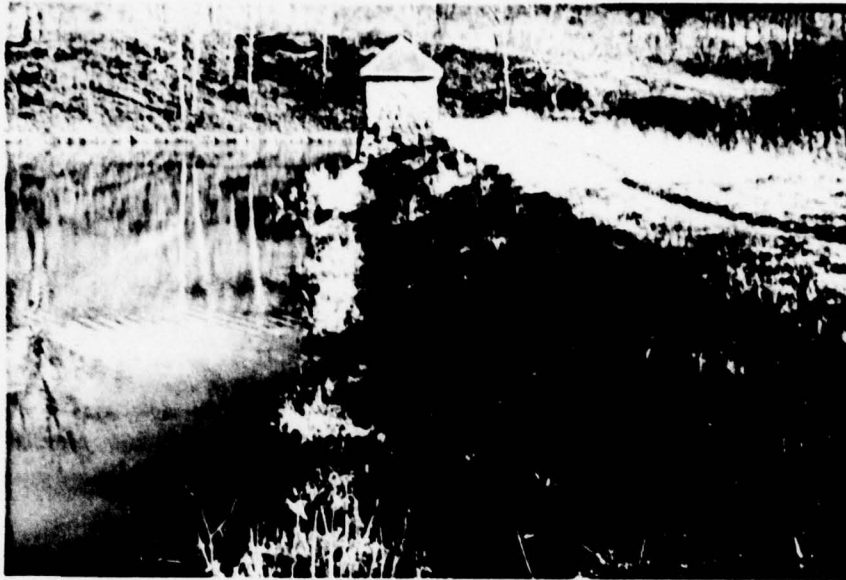
4.3 Maintenance of Operating Facilities. The maintenance of the operating facilities is considered to be fair. Due to inadequate access into the control tower, the blow-off valve located at the bottom of the control tower was not observed. However, the blow-off valve was operated and observed to be functional. Water company personnel reported that the blow-off valve is operated annually. However, no formal records of valve operation are being maintained.

Photograph No. 5  
Control tower.
